Damage Survey in the Surrounding Area of the Capsizing Accident of the Cruise Ship ‘Dongfangzhixing’ on 1 June 2015

National Meteorological Centre, China

WSN16, Hong Kong

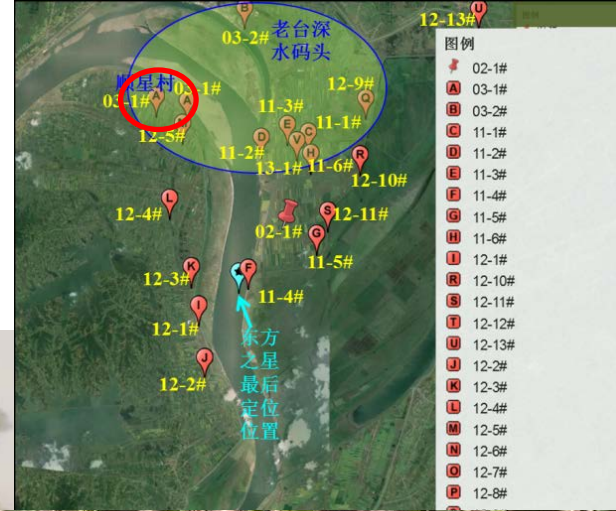
Shunxing Village, Huan Province, at the west side of the Yangtze River

EF0-EF1 damage

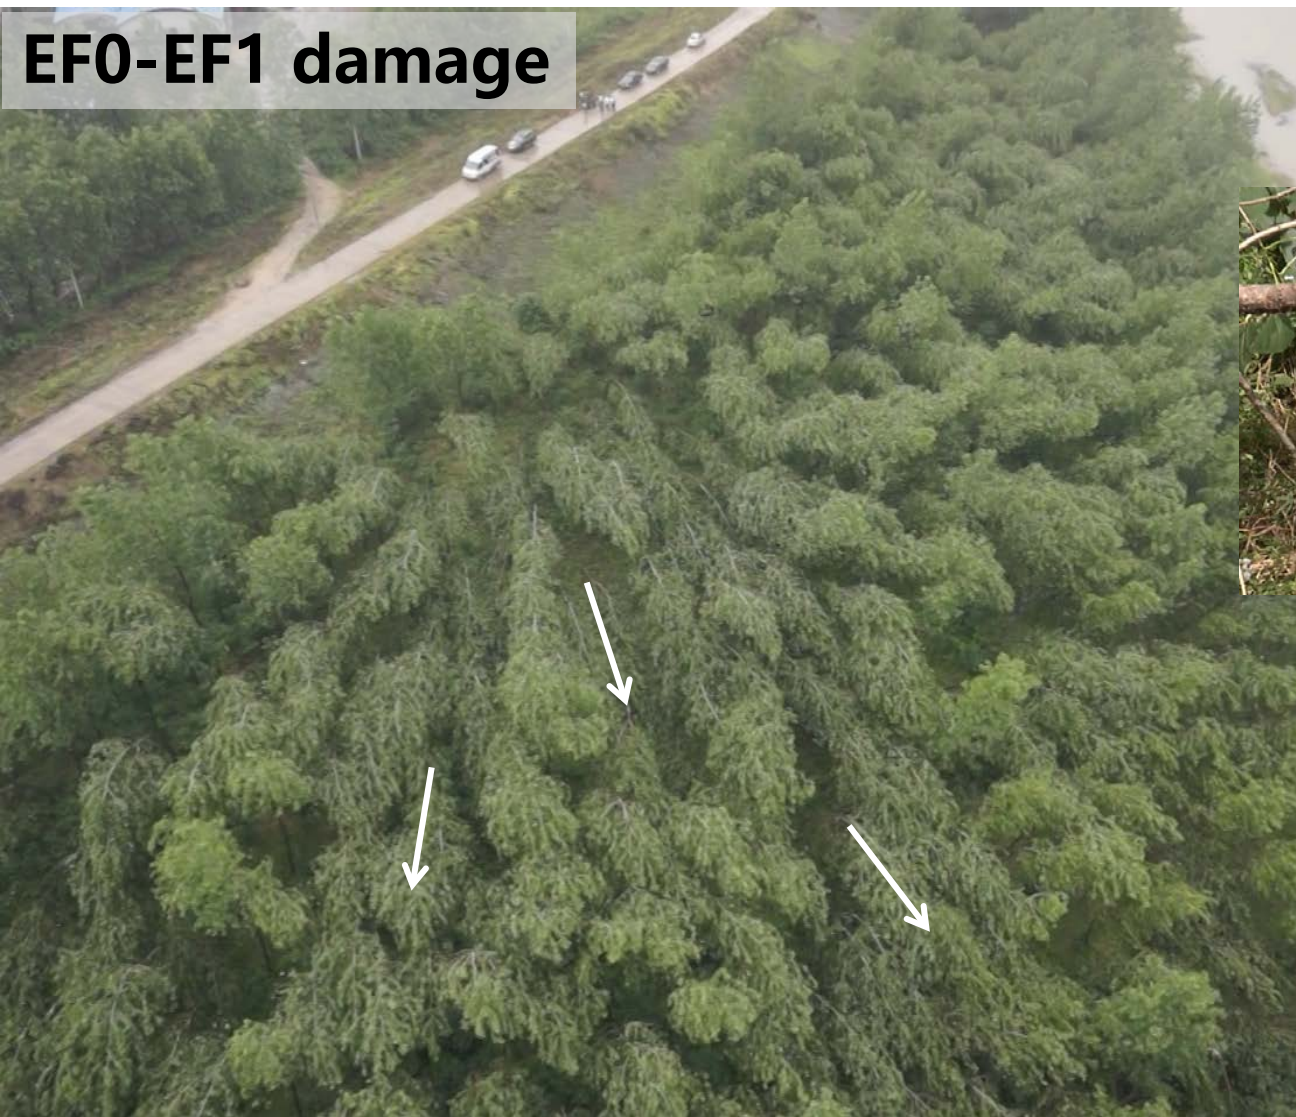
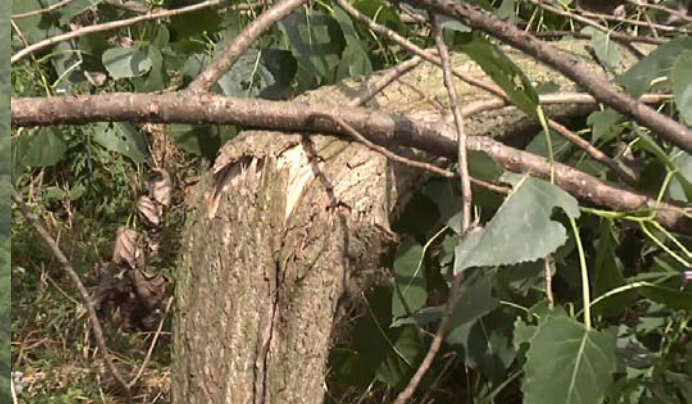
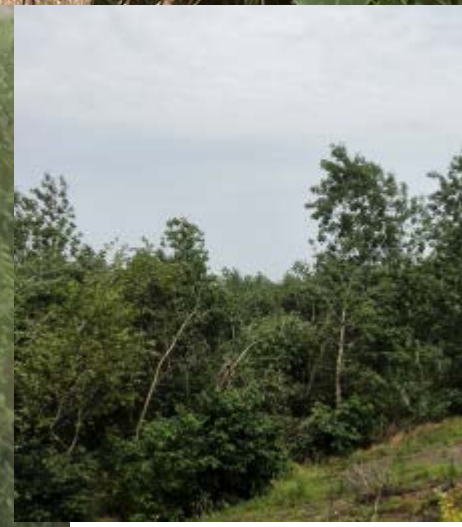
EF1 damage

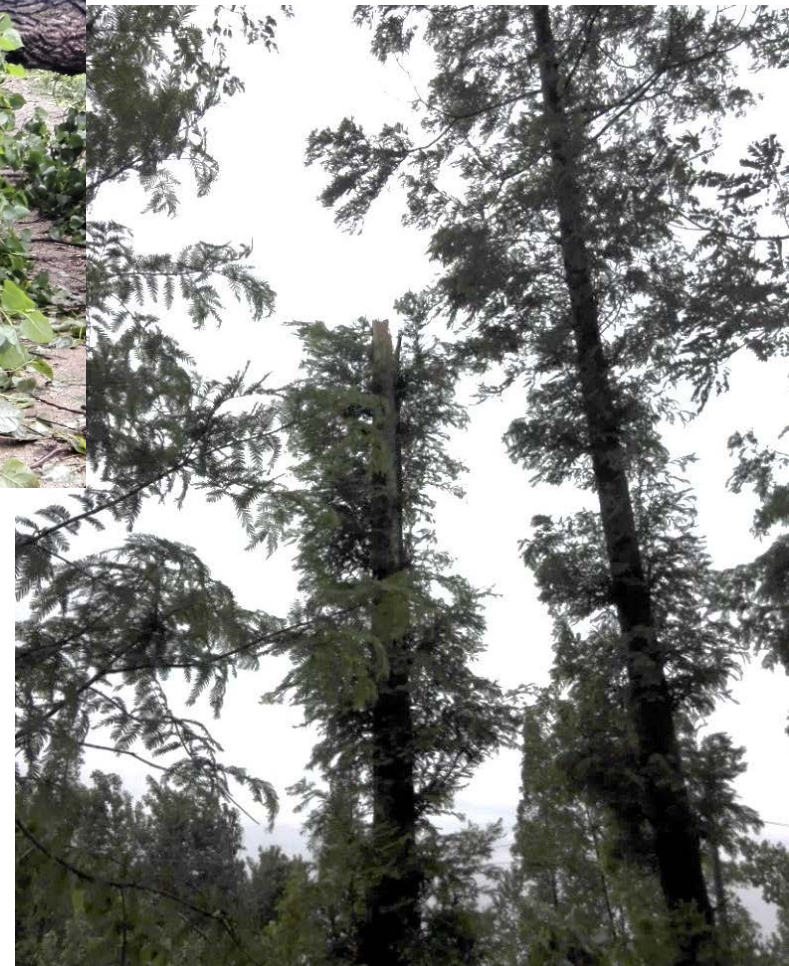
An aspen tree with a diameter of about 50 cm was snapped in Shunxing village, corresponding to an estimated wind speed of about 49 m s^{-1} (110 mph).

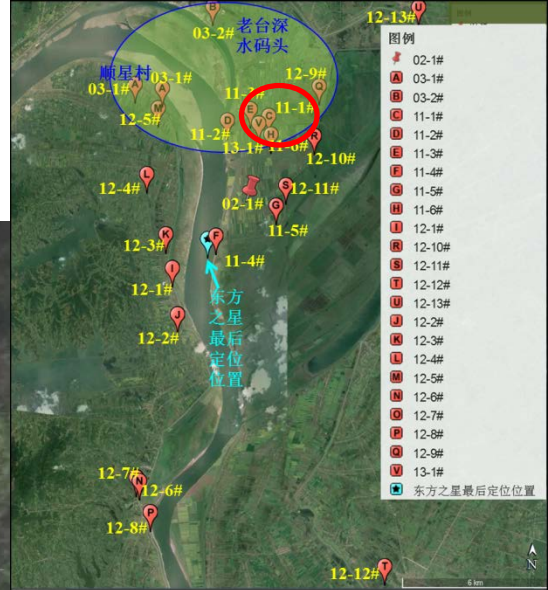
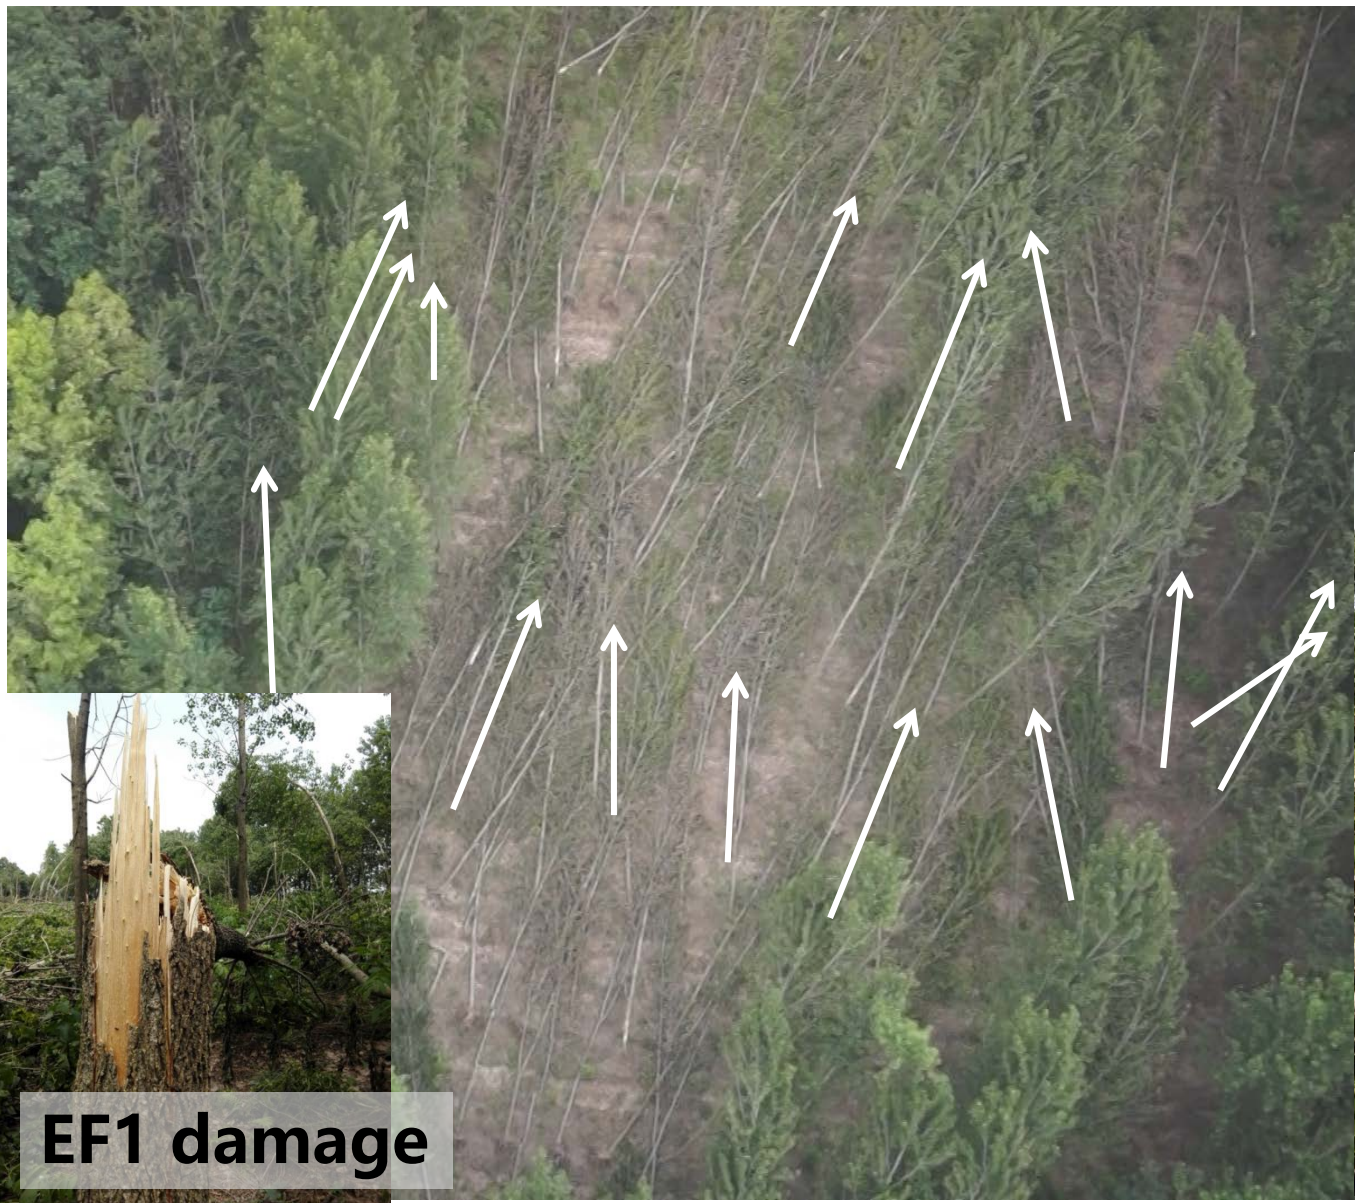
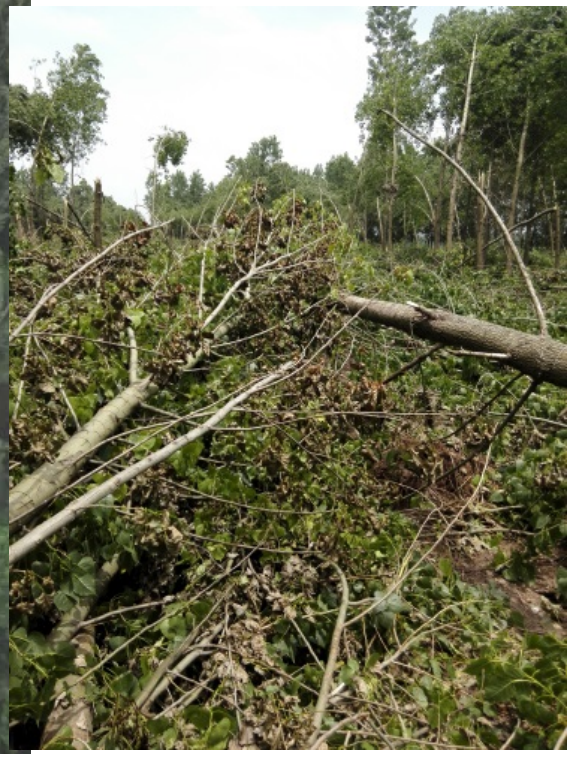
Woods near Sitai Village (11-1#) at the east side of the Yangtze River

The size of the damage area is about 200 m X 200 m

EF1 damage

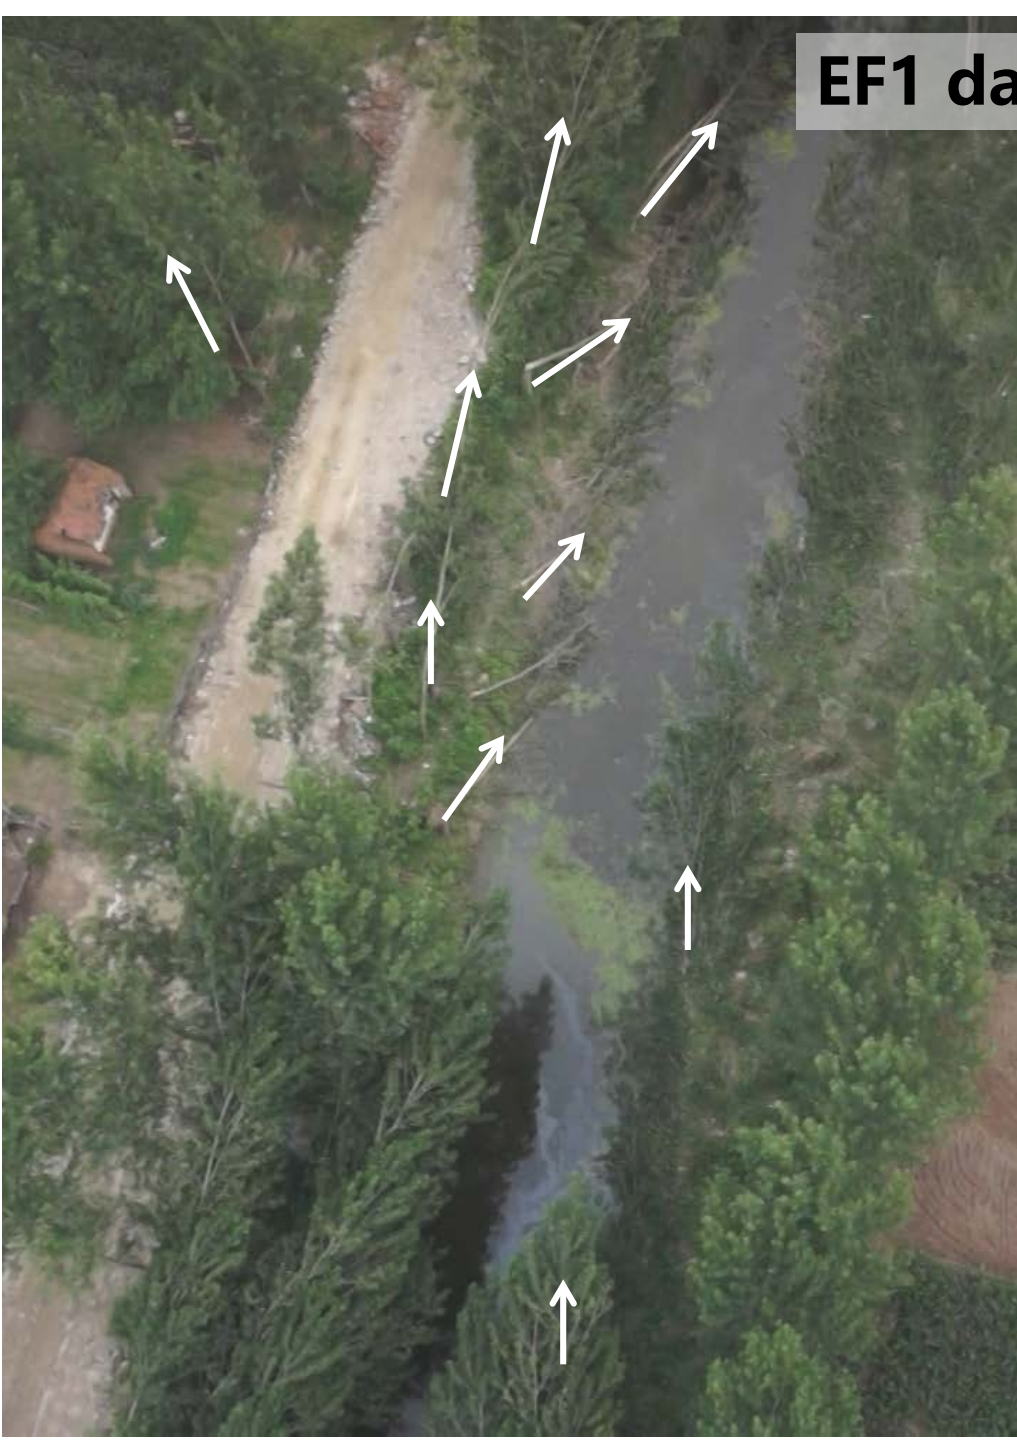
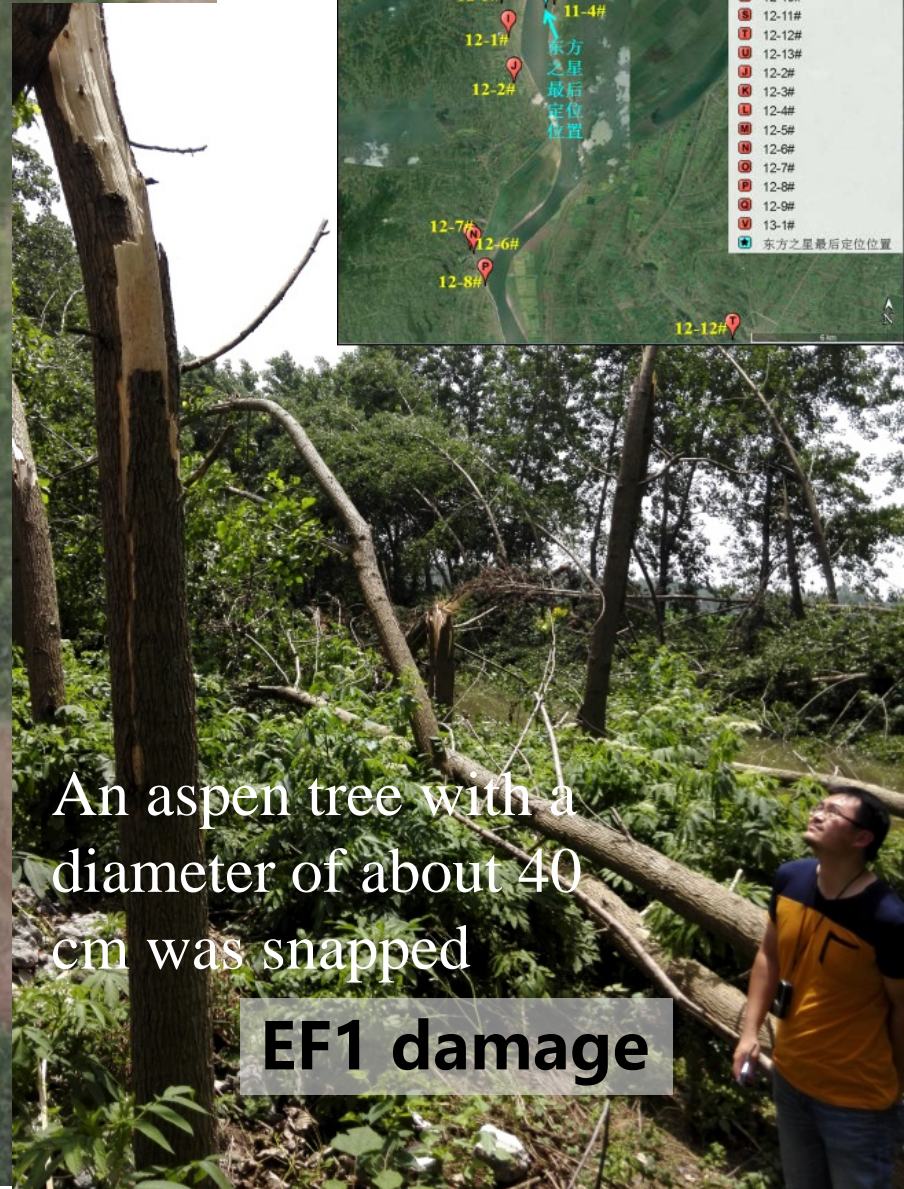
An aspen tree with a diameter of about 40 cm was snapped

EF1 damage

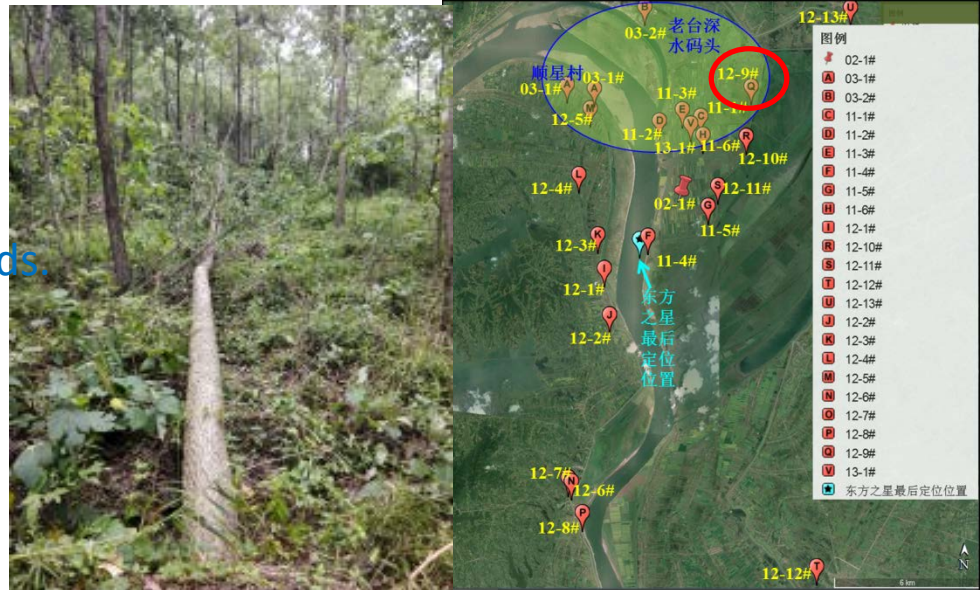
Woods Neighboring Xingouzi Village (12-9#)

Many trees were bent and uprooted by the winds.

EF0+ damage

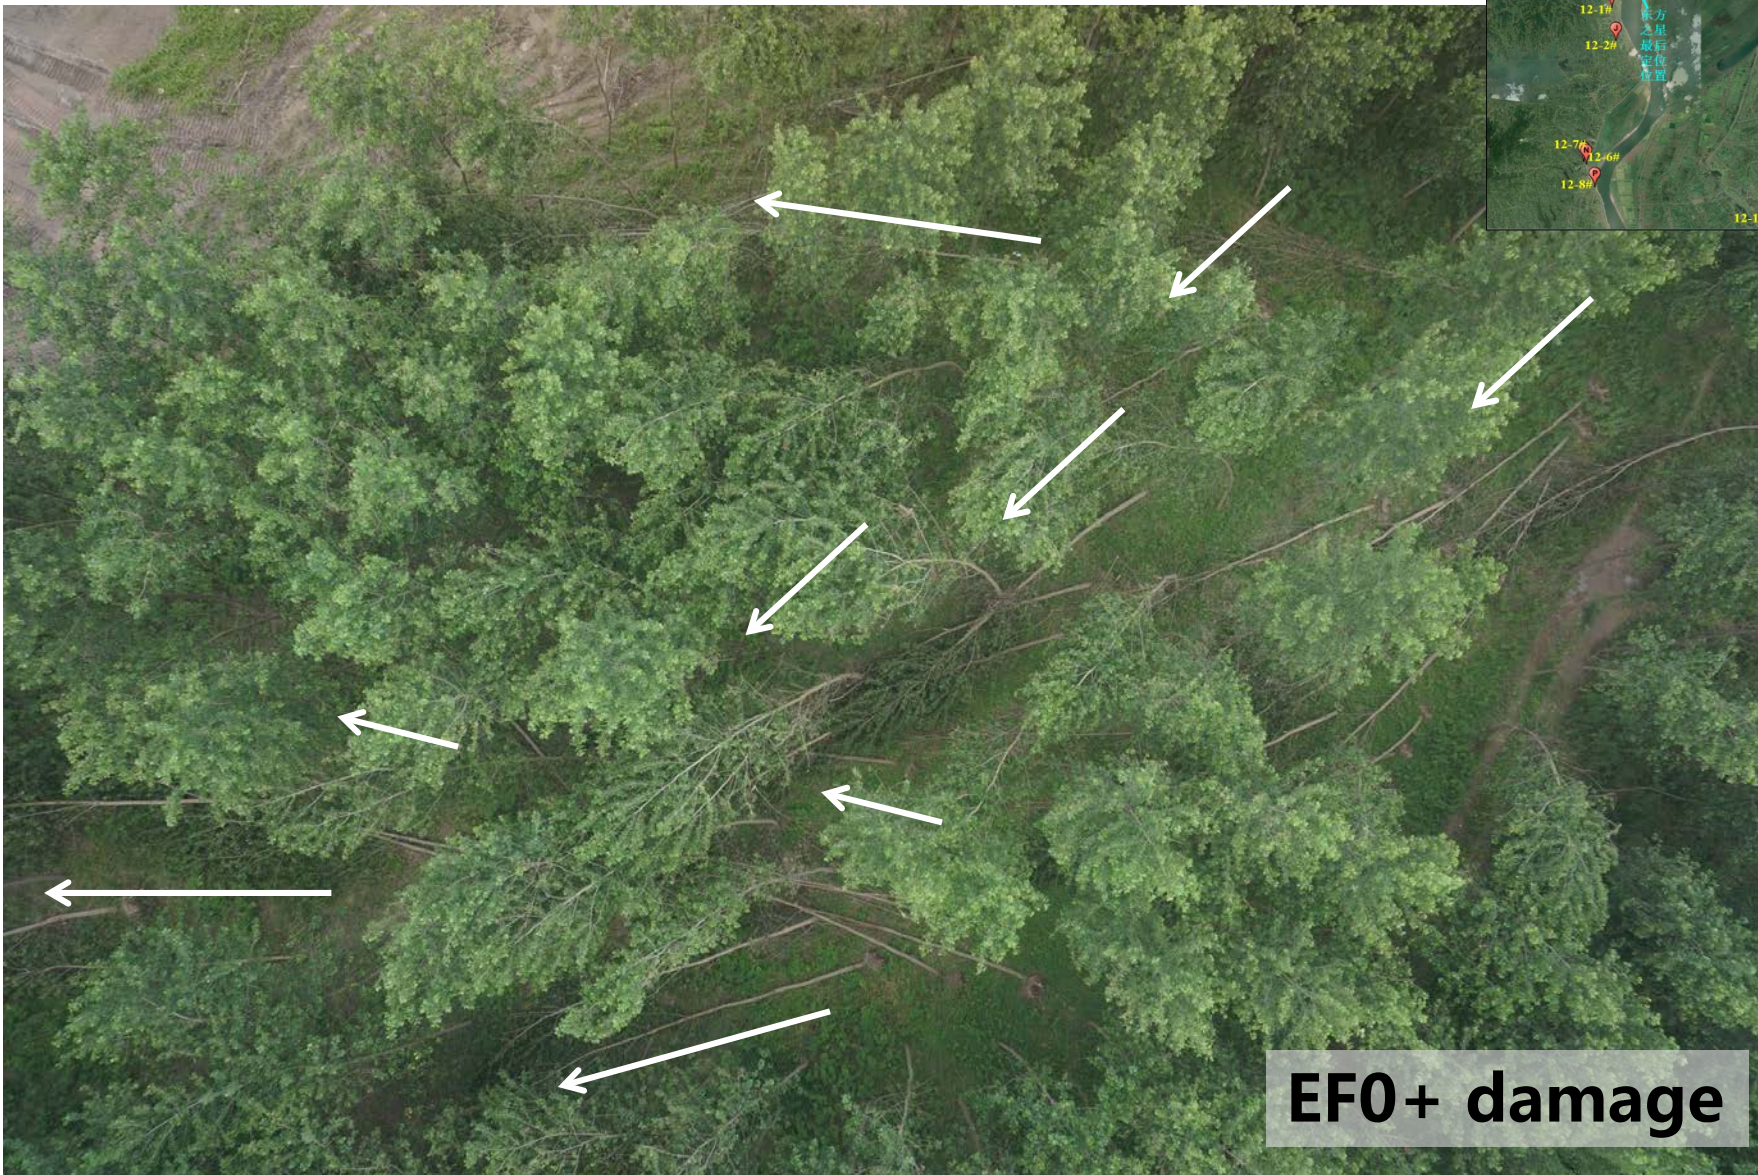
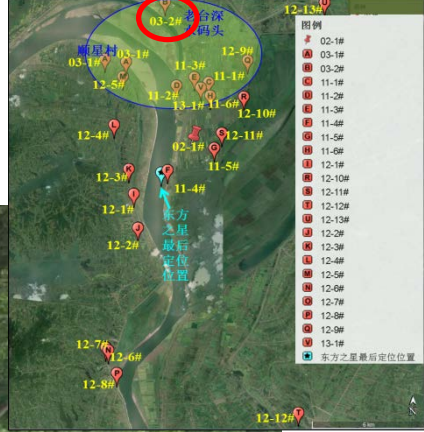
Laotai Dwarf (03-2#) , Hubei Province

EF0+ damage

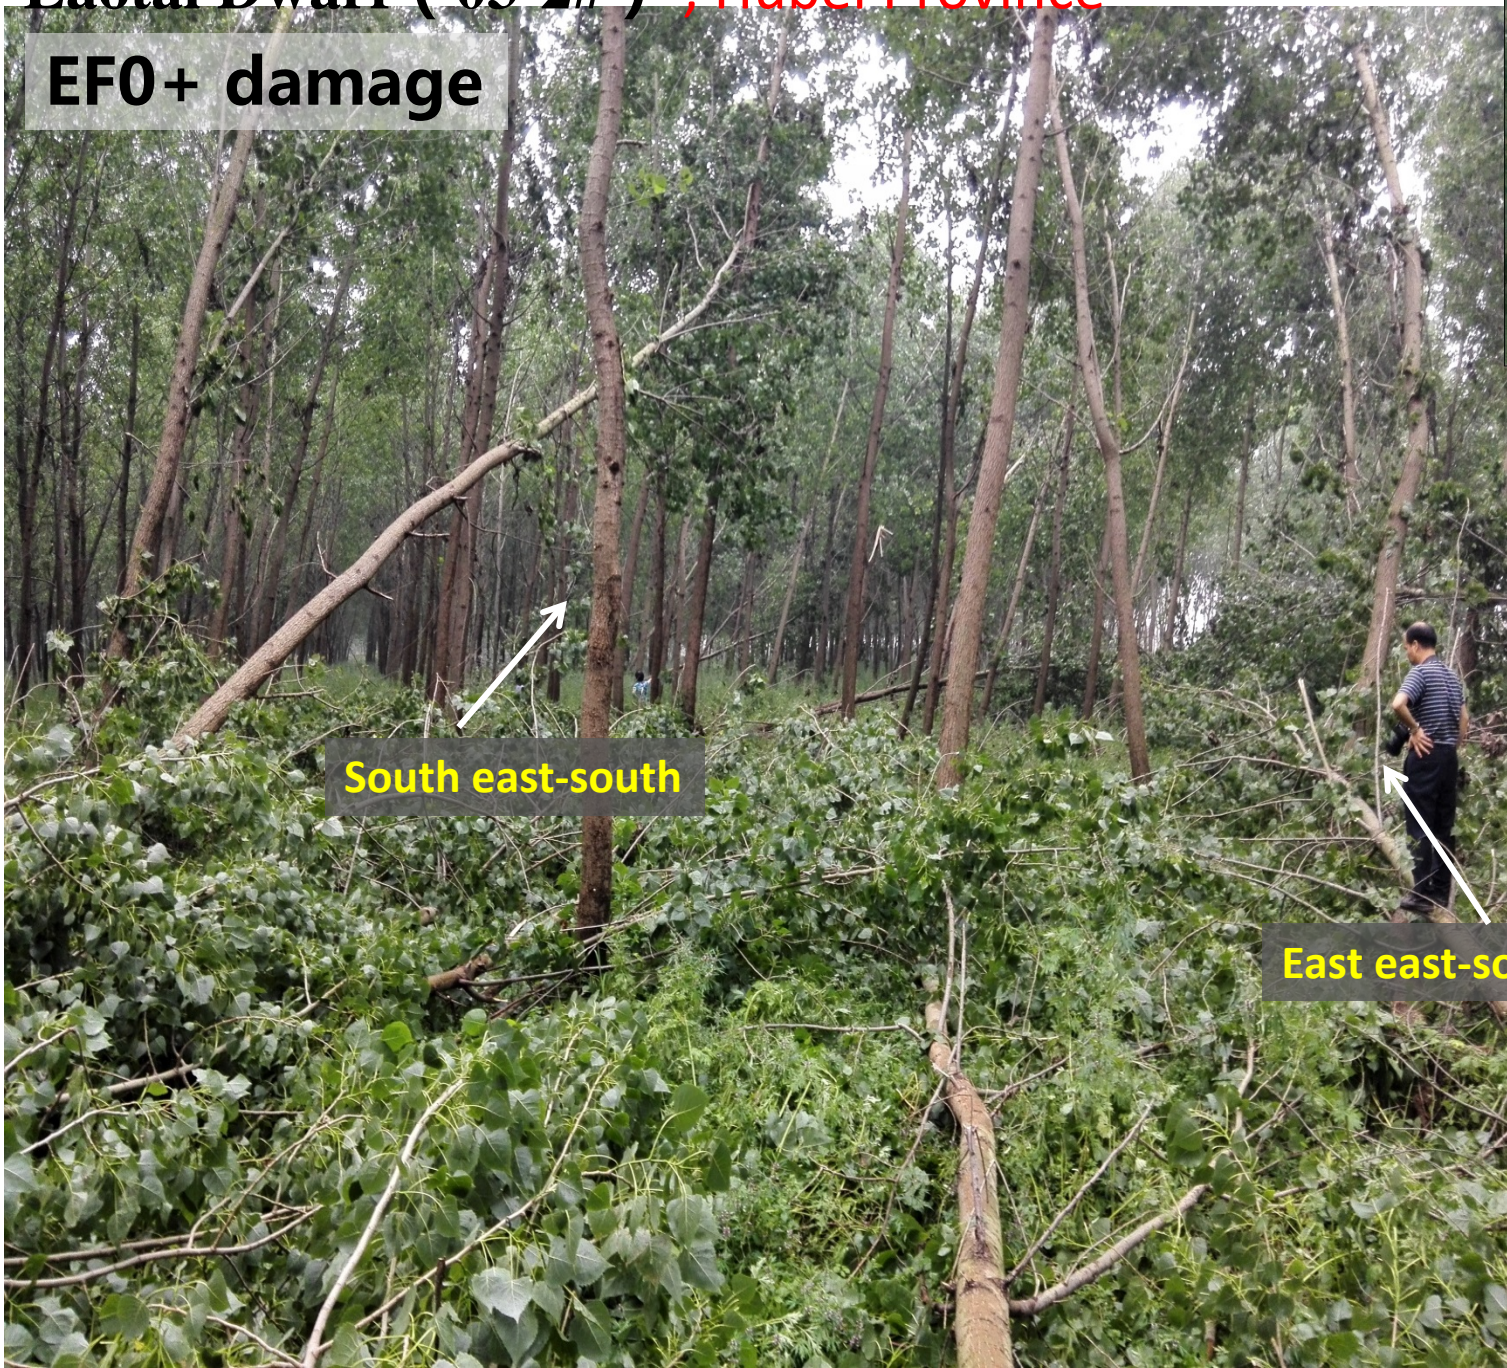
Laotai Dwarf (03-2#) , Hubei Province

EF0+ damage

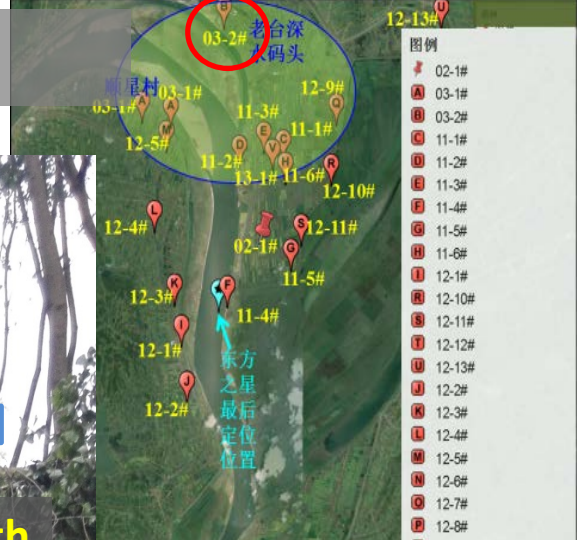
Laotai Dwarf (03-2#) , Hubei Province

EF0+ damage

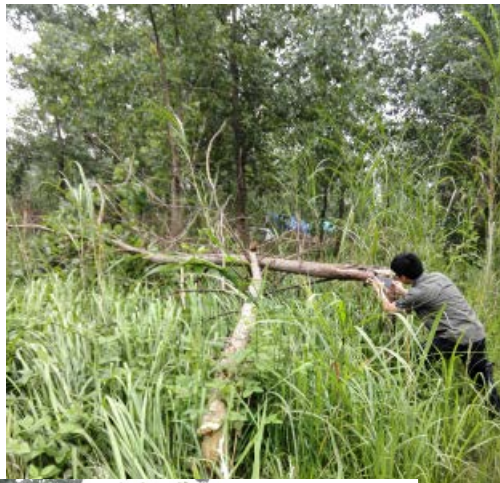
East side neighboring
Capsizing
Position of
"Dongfangz
hixing"
(11-4#)

EF0 damage
(snapped dead tree)

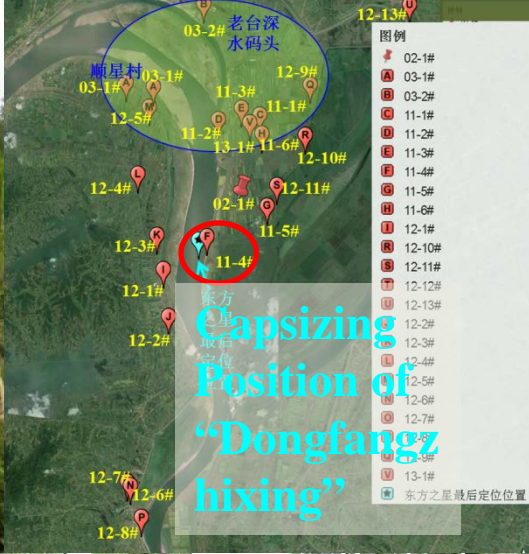
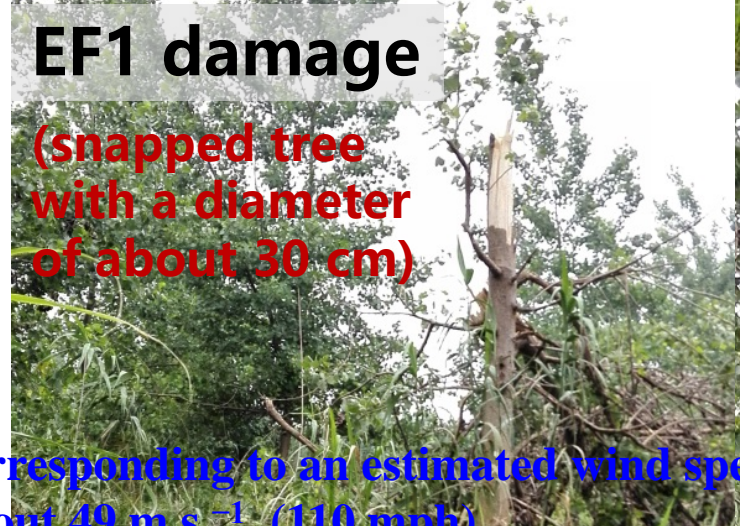
EF1 damage

(snapped tree
with a diameter
of about 30 cm)

corresponding to an estimated wind speed of
about 49 m s⁻¹ (110 mph).
