# **Did Weather play a key role for the crash of Air Asia Flight QZ 8501? A Review !**

**Anupam Kumar**

*Nanyang Technological University, Singapore*

*25th July 2016*

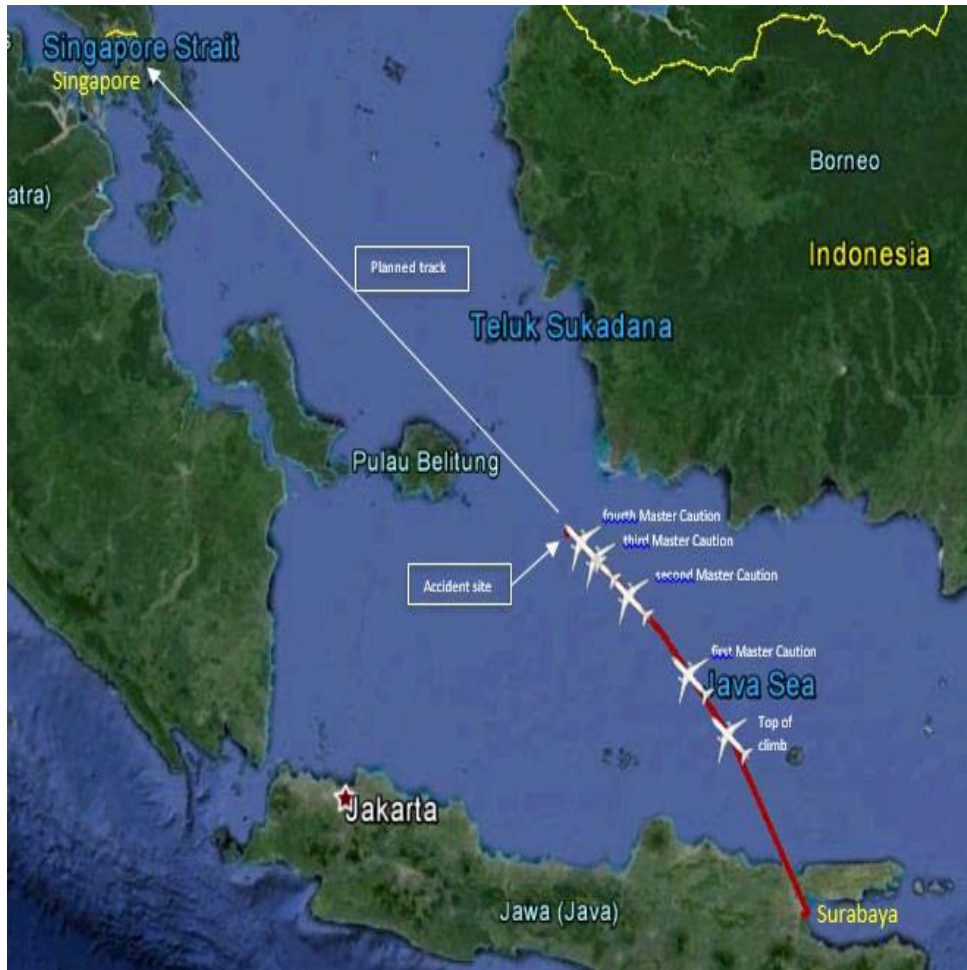
# Air Asia QZ 8501 Flight Track

**2231 UTC** : Taxi; **2235 UTC**: Take Off

**2249 UTC**: FL 320

**2257 UTC**: anti Ice ON

**2301 UTC**: 1<sup>st</sup> MC

**2304 UTC**: Request for 15 miles left of track to avoid weather

**2309 UTC**: 2<sup>nd</sup> MC

**2311 UTC**: Flight turned to left to avoid weather (acknowledged)

**2312 UTC**: Requested for FL 380 and was asked to standby ATC

**2313:41 UTC**: 3<sup>rd</sup>MC

**2315:36 UTC**: 4<sup>th</sup> MC

**2316 UTC**: Clearance to fly FL 340

(No response from Pilot)

**2316:27 UTC**: 5<sup>th</sup> MC

**2316:44 UTC**:6<sup>th</sup> MC (A/P disengaged)

**2317:18 UTC**: Stall Warning

**2317:41 UTC**: A/C started descending at 20,000 ft/min

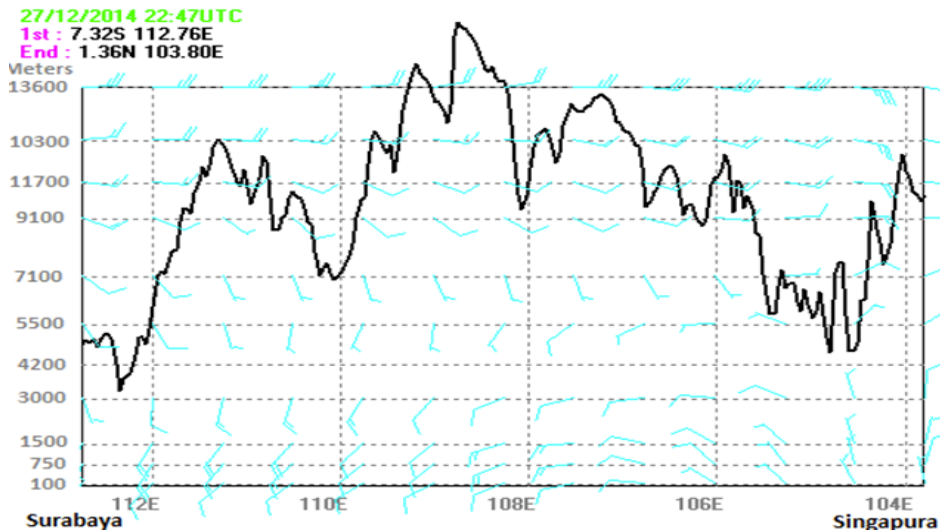
# Meteorological Information 27<sup>th</sup> Dec 2014 at 23 UTC

- ❖ Shows partial area of towering cumulonimbus clouds formation. Top of clouds approx. **24,000 feet up to 44,000 feet** on the vicinity where the aircraft was flying.
- ❖ The wind direction when the aircraft was flying mostly westerly **with 15 to 20 kts**. The outside air temperature ranging from **-56° C to -62° C**

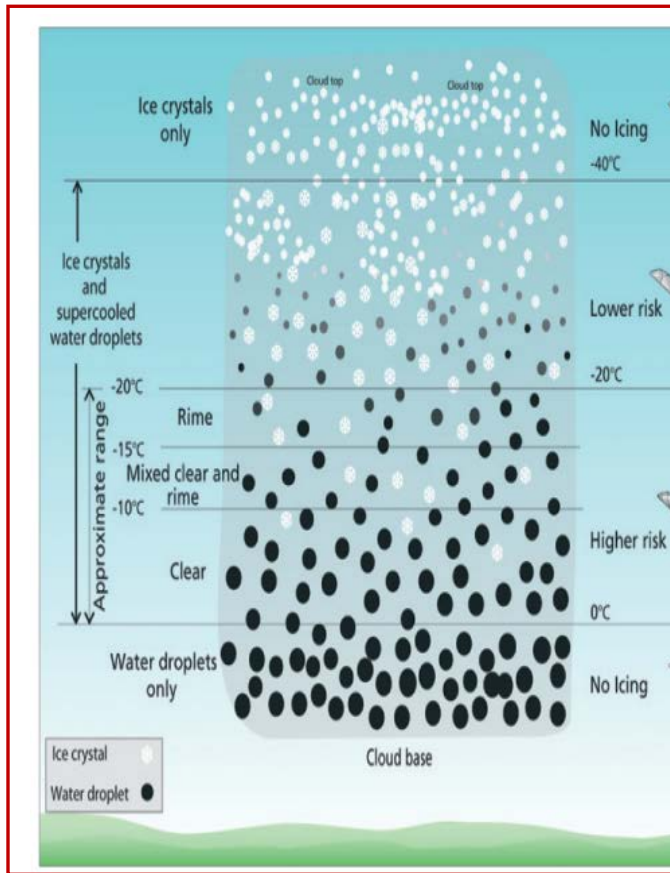
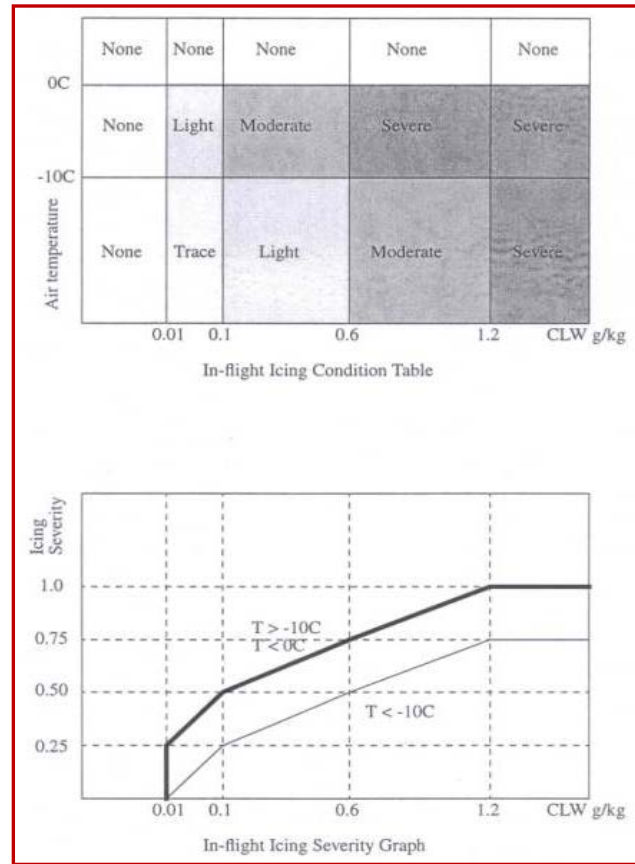
# In Flight Icing Conditions & Severity

The severity number is interpreted as follows:

$\leq 0.25$  None

$>0.25$  and  $\leq 0.5$  Light

$>0.5$  and  $\leq 0.75$  Moderate

$> 0.75$  Severe

- Note: 1. In-flight icing only occurs when the air temperature is below 0 Deg. C
2. Icing severity increases with increasing cloud liquid water content
3. Clear icing has a more severe impact on aerodynamic performance than rime icing

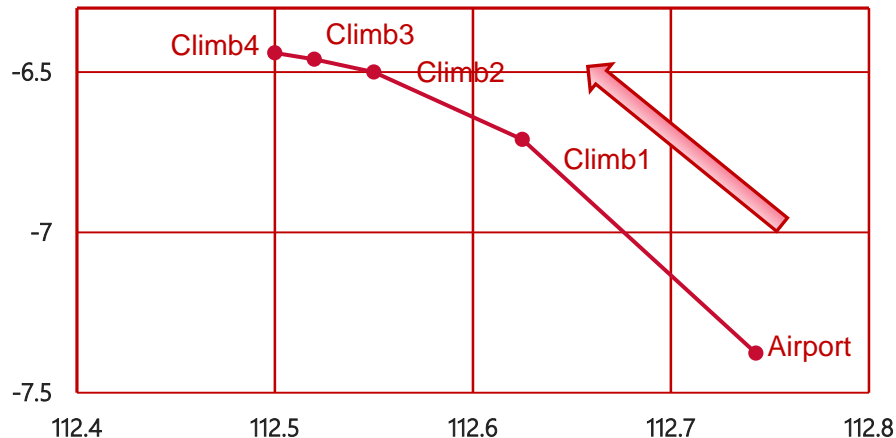
## From Take off to FL320

Georeferenced Climb locations with approximation

Locations	Positions
1	Climb-1
2	Climb-2
3	Climb-3
4	Climb-4

A/C Location	Time (UTC) 27 <sup>th</sup> Dec-2014	Pressure (hPa)	CLWC (g/Kg)	Temp (°C)	Riming Intensity (Fraction)	Dew Point Spread	Relative Humidity (%)
Climb-1	22:40	700	0.556	9.932	0.698	-0.00703	100
Climb-2	22:45	500	1.3909	-3.663	0.81	-0.0006942	100
Climb-3	22:50	375	1.38256	-20.2211	0.749	-0.000823	100
Climb-4	22:55	275	1.13342	-33.1121	0.686	-0.004703	100
